# N Steering FACTORY

# SERVICE INSTRUCTION LEAFLET

BENTLEY MOTORS (1931) LTD.

TO FIT A NEW CROSS STEERING TUBE - BENTLEY  
3½ or 4¼ litre.

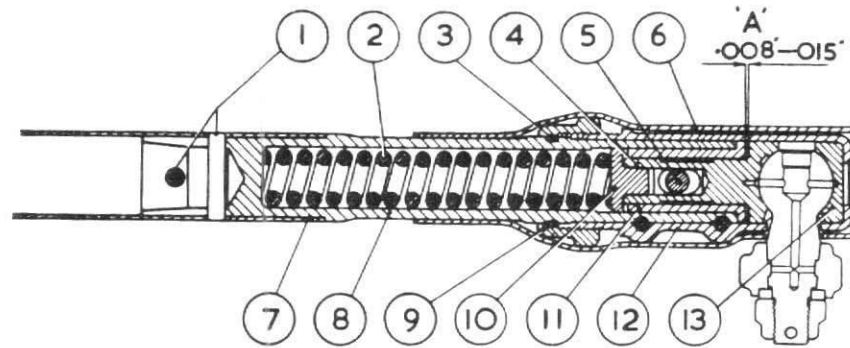
FIG. 1. SECTION THROUGH CROSS STEERING TUBE JOINT.

- (ii ) Slacken off the steering joint nut (9, Fig.1), of the original tube from one to two flats and remove the two clamping bolts from the end of the tube and then carefully remove the tapered cotter pin (5) situated between the clamping bolts.

- (iv ) The next operation is to assemble all the parts removed (with the exception of the cotter pins) from the original tube to the new tube and loose end piece in order to set a gap of .008" to .015", (as shown at point 'A' Fig.1), at each end of the tube as described below and then drill and ream the tube to take the tapered cotter pins also described below.

- a) Place one of the steering joint nuts (9) on the tube or the loose end piece and then fit the retaining ring (3) in the groove provided.
- b) Place the spring (2) into the tube and assemble to the tube the remainder of the parts (including any packing washer/s should they have originally been fitted) in their proper sequence (See Fig.1) including the ball pin.

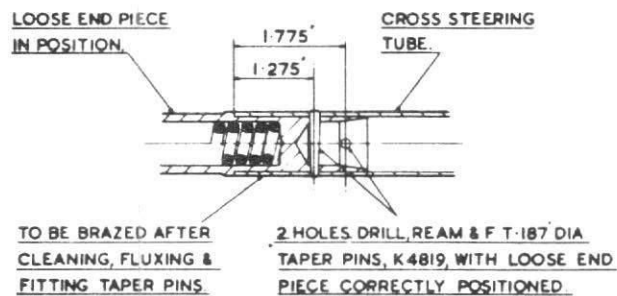
FIG. 2.

- (a) Jack up the front of the car until the tyres only make light contact with the ground.
- (b) With the nuts of the cotter pins facing towards the front of the car, temporarily fit the cross steering tube. The locating washer as fitted to the underside of each of the cross steering levers must be correctly positioned. The castellated nut of the ball end pins need not be fully tightened up at this stage.
- (c) Check the toe-in of the front wheels. It is usually found when fitting a new cross steering tube that there is too much toe-in. If the toe-in exceeds  $\frac{1}{8}$ ", then it will be necessary to shorten the end of the tube by degrees until the correct amount of toe-in has been obtained.

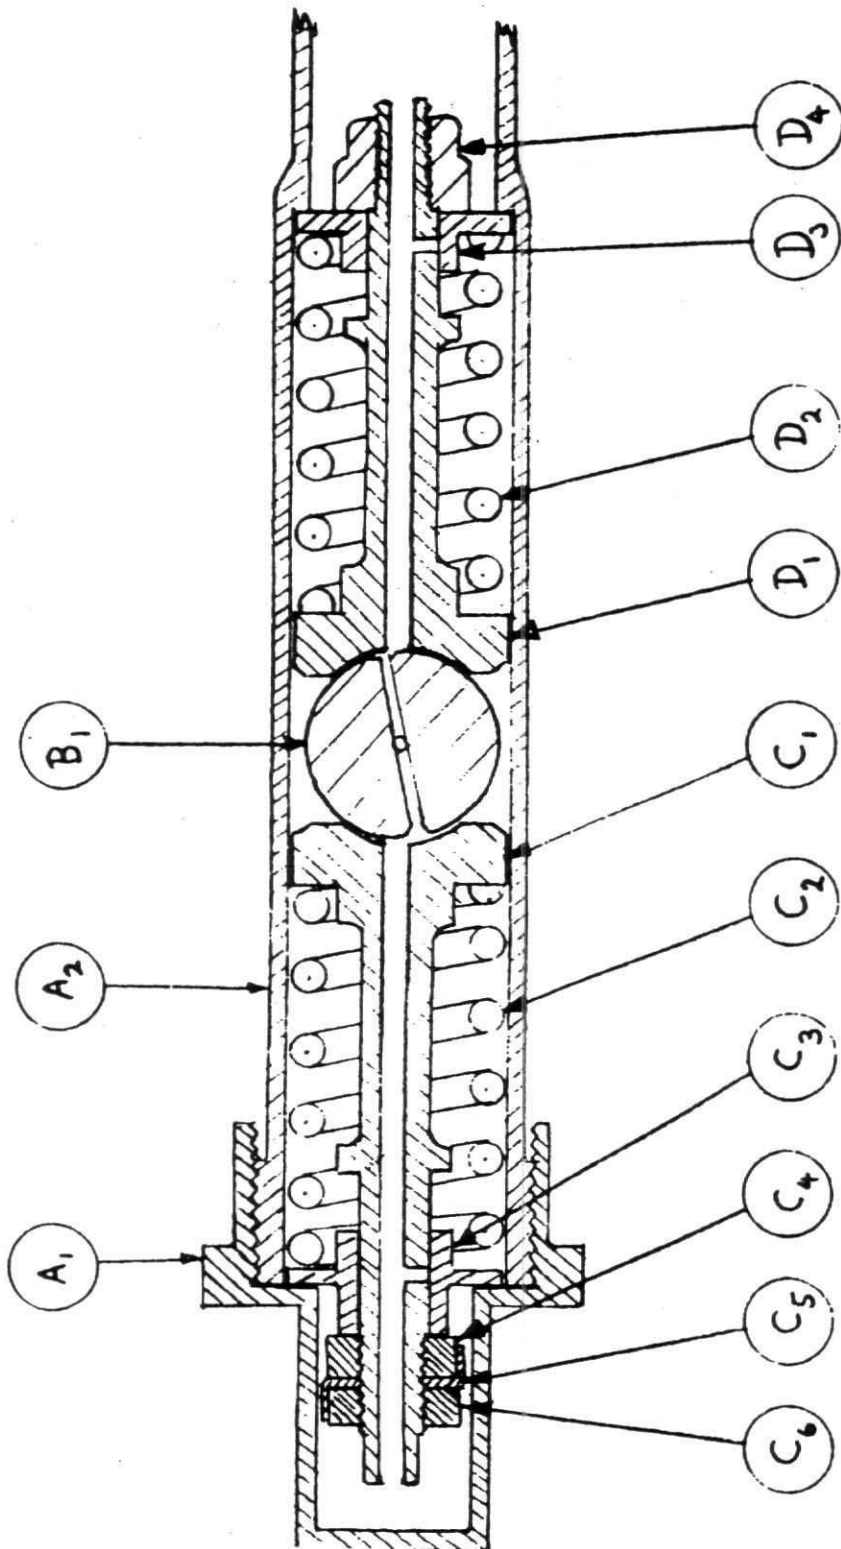
SIDE STEERING TUBE

Correspondence received from members and personal experience show that there is a general lack of understanding of the operation and adjustment of the rear ball joint on the side steering tube of most prewar Rolls-Royce chassis. The characteristics of front suspension with a rigid front axle are such that gyroscopic effects from the front wheels can cause very strong kicks on the steering when the car is driven over rough roads. The small degree of reversibility of the worm and nut steering box would allow the kicks referred to above to produce very large shock loadings in the steering mechanism if all the joints were rigid, and the purpose of the side steering tube rear joint is to introduce a controlled amount of flexibility into the system.

It goes without saying that C1 and D1 should be a good fit in both the bore of the tube A2 and their respective guides C3 and D3, to avoid any lateral movement of the ballpin relative to the tube. Many cars now have steering tubes which are quite worn internally, giving rise to slop in the steering system.

It was stated in the article in the Bulletin that the correct adjustment for the joint was obtained with both pads just contacting the ballpin in its central 'rest' position. The nuts C4 and D4 would then be hard against their respective stops, and the pads would not be exerting any load on the ball. The springs would only begin to deflect when the load on the ball exceeded the pre-load in the spring. However, in this state the balljoint is not self-adjusting in the event of wear, and an excessive amount of one-shot oil will leak from between the ballpin and the pads.

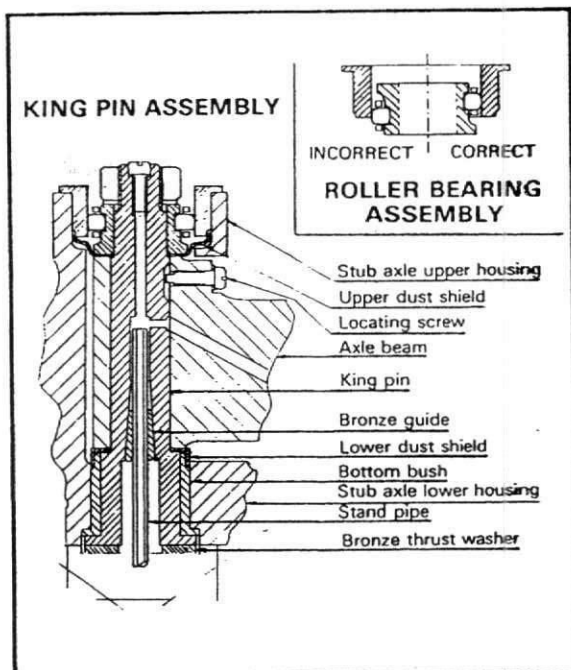
Recently I have dismantled several front axles in which the inner race of the roller bearing had been assembled with the flanged face uppermost, as shown on the left hand side of the detail drawing of the bearing. The results of this are twofold. Firstly, as the rollers extend some way below the edge of the outer race they are liable to come in contact with the shroud. They will then form indentations in the shroud as the top nut is tightened, and the kingpin will feel tight and 'notchy' as the stub axle is turned from lock to lock. The rollers will skid on the raceways rather than roll, and if they do succeed in rolling from one indentation to the next they may well destroy the shroud completely. This had occurred in one of the axles dismantled.

Secondly, and this is potentially very much more dangerous, as the rollers protrude below the bottom face of the outer race by about 60% of their length, only a fraction of each roller will be carrying the side thrust exerted by the kingpin. In addition, there will be a stress concentration at the lower edge of the outer race. These factors will lead inevitably to early failure of the bearing. In the case of one of the axles I dismantled I found that the rollers had worn or gouged a large step at the bottom of the outer race. The extra sideways play which had developed at the top of the kingpin had allowed the bottom bush to wear very bell-mouthed, and a comparatively new kingpin assembly had to be replaced after a very short life.

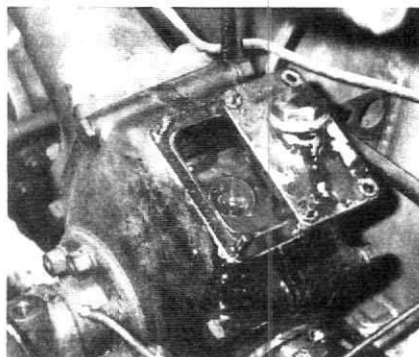
**Above:** With road wheels straight, the oil seen through the filler plug in the steering box is only a small amount trapped in a depression in the nut surrounding the worm. **Below:** With road wheels turned hard right, the nut moves up and exposes the real oil level. Check it carefully.

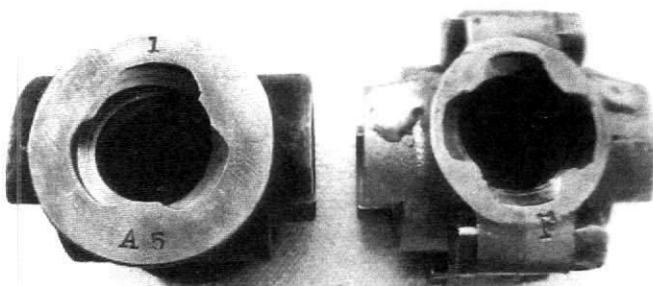
Three start solid nut (left) and four start split nut (right) are called three and four start because there are three threads that start engaging simultaneously for the nut on the left; four on the right. The numbers correspond to the numbers stamped on the worm threads. The four start nut is suffering from a crude attempt to repair cracked lips.

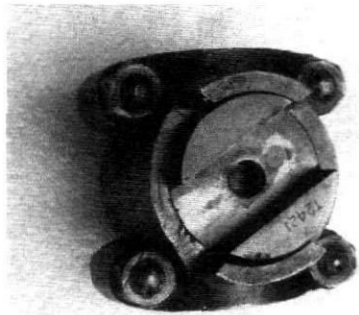
*Cheese T2421 in split steering nut. The lugs have been bent and split in an accident and now do not support the cheese perimeter - it is junk.*

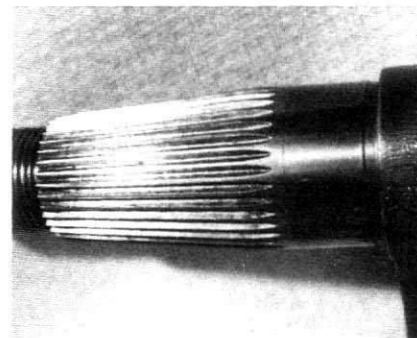
*Wear on rocking shaft. The faint line just to the right of the splines shows wear of .001" which, when combined with wear in the rest of the system causes the shaft to tilt. Other than replacing with an unworn shaft, the only cure is hard chroming to size. Once there is this small wear on the shaft, evidenced by a clicking while in a tight turn, you can be sure everything else has started to wear – ball ends, bearings, nut, cheeses, pivots, pivot bearings, the lot. The good news is that this only happens every 100,000 to 250,000 miles.*

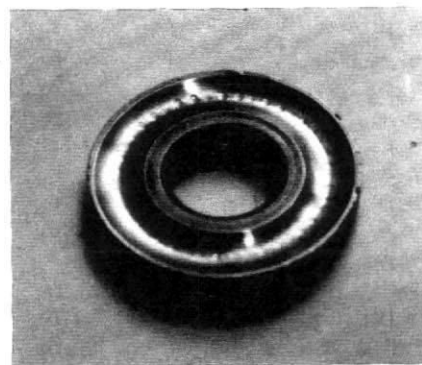
Indentations on pivot pin thrust washer (F6974)
