# From Here to Ether-Ternity

# From Here to Ether-Ternity: Help for B154KT

### FROM PUTTY TO PERFECTION? A BENTLEY RESTORATION PROJECT

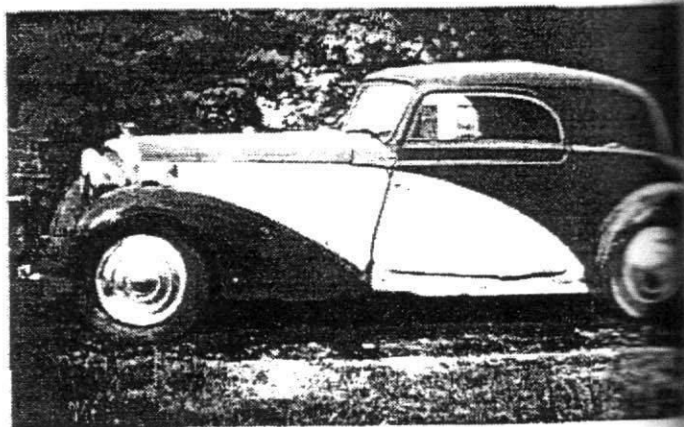
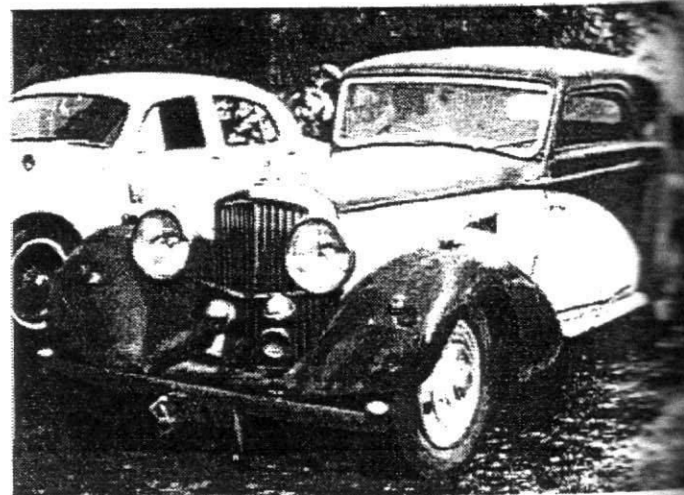
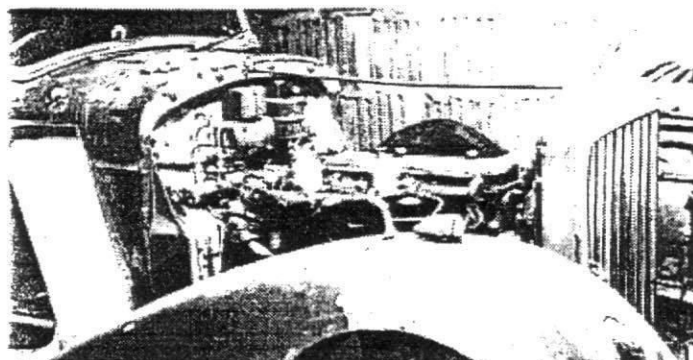
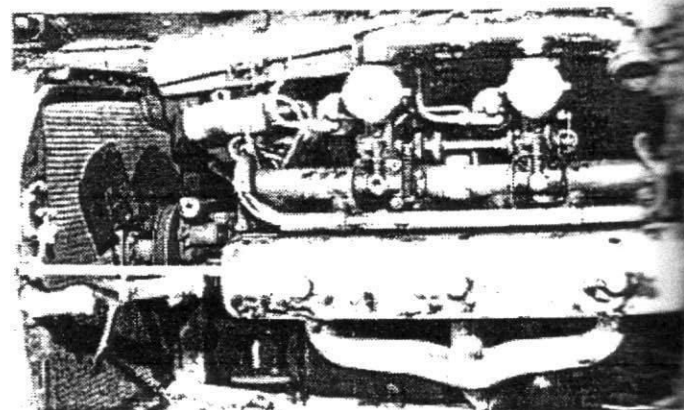
The entire car, so help me, has been coated with a layer of putty, ranging from less than a sixteenth inch thick to two inches. There is paint underneath the putty — a couple of colors of green in fact — and no less than three colors of green on top of the putty! The putty hides many holes rusted through the metal of the darn thing (it is a steel body with aluminum hood) and seals off the former sunroof.

A headliner has been installed which conveniently ignores the existence of the sunroof. When the doors are opened they fall off as did the trunk when I opened it. All this and the car's engine runs and on all six cylinders though it does overheat. Just a minor problem, I'm sure!
