# N Steering FACTORY

# SERVICE INSTRUCTION LEAFLET

BENTLEY MOTORS (1931) LTD.

TO FIT A NEW CROSS STEERING TUBE - BENTLEY  
3½ or 4¼ litre.

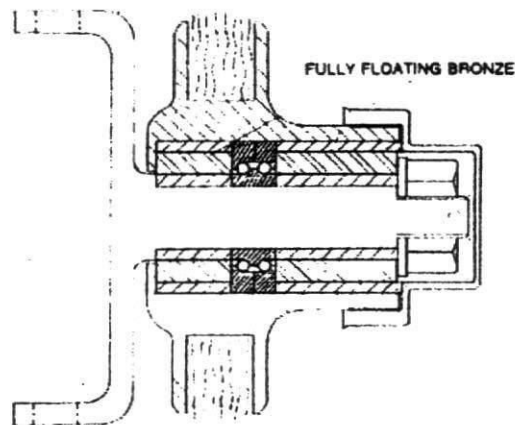
(B184/36)

The arrangement was so unusual that we took the attached sketch for posterity. The central race is for end thrust purposes only, journal loads being taken on the two fully floating bronze rings running on inner and outer hard steel sleeves located endwise, all components being easily and inexpensively replaced in the event of wear or neglect. These undoubtedly caused the above mentioned resistance to movement, to which could also be added the drag of the plain bearings in the axle and gearbox.

Front wheel bearing arrangement.  
Rolls-Royce two cylinder. 1904

In recent times we were asked to do some general repair work on Rolls-Royce Motors' own two cylinder car, SU13 (Susie), and among this were some rectifications to the wheel bearings.

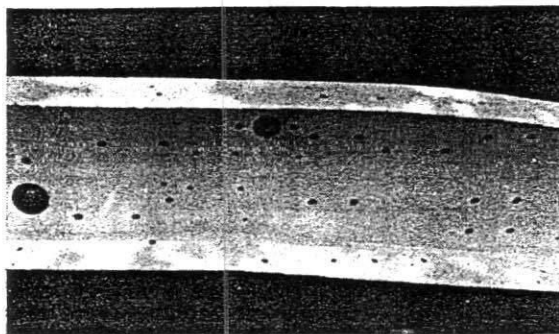
The picture shows the channel frame section which is forward of the rear spring fixtures and aft of the front spring fixtures. It is the most heavily stressed part of the frame. All the holes are 'official' holes. Rolls-Royce had a monopoly in holes. If you could discover a place to drill a hole, and drilled it without permission, your guarantee instantly became null and void.

The vertical part of the frame carries the load. The top half of the vertical part is in compression, the bottom half is in tension. If you are feeling depressed, and are looking for trouble, look for cracks along the bottom half because, whereas materials do not mind being squashed, they definitely do not like being pulled apart. The narrow horizontal parts of the channel frame are to prevent side wobble, a job which it only does half-heartedly, and requires considerable backup from massive crossmembers. When a front wheel goes into a pothole the frame dives in after it. And flexes. When independent front suspension came in, it was goodbye for the channel frame and hello to the frame/body unit.

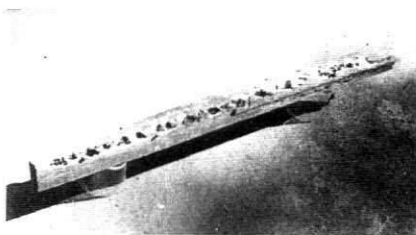
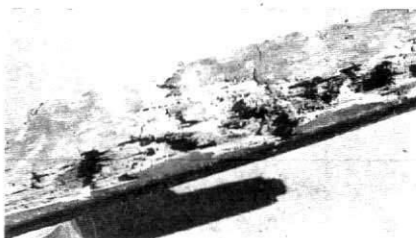
In fact, the tight steering was the reason I was unable to avoid an enormous pothole on Rt. 15 near Blossburg, PA, on the return home. Coming down a long grade at about 50 mph, we hit the pothole, the driver's door popped open, was caught by the wind, and folded back against the rear fender. You can imagine what this did to the wood framing and the door skin. Surprisingly, we were able to shut the door and latch it, but rigged a lashing to secure it more surely. The door has since been repaired, but there was some rotten wood which we have replaced. This sort of invisible damage (rotten wood) can occur to any coachbuilt car.

**Above:** This rotten wood in the bottom door sill came to light following B47LE's encounter with a vicious pothole. The 'bump' caused the driver's door to fly open, and the damage done required repair to the door. **Below:** Closer view of damaged wood. Let no one say that coachbuilt bodies are without vices of their own.

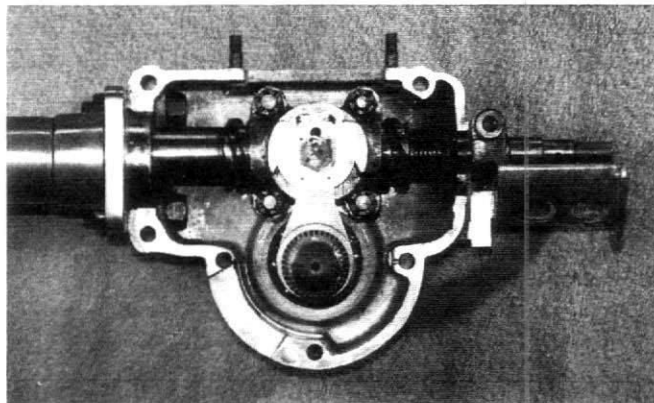
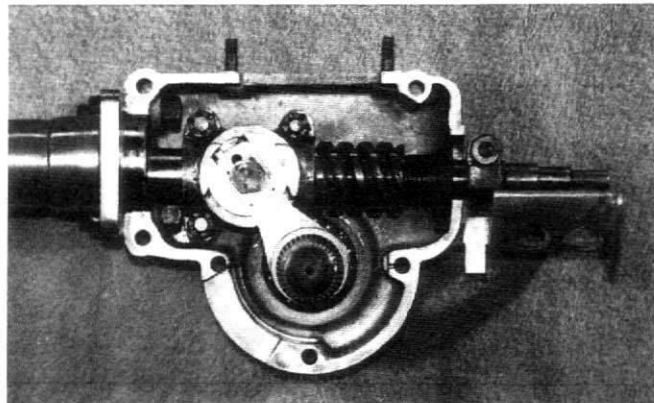
*Steering box elements horizontally, left to right:- stationary steering tube, steering worm tube (worm in the steering nut), spring, oil plate, concentric control tubes for ignition, governor, carburetter, and switch which are ingeniously keyed to slide up and down, not twist, and switchbox bracket. Lower center of box:- splined end of the rocking shaft with an arm secured to the slot in the cheese fitted in the steering nut. The front wheels are straight ahead in the left picture, full right in the right picture. The movement of the control tubes is what makes it difficult to seal the Ghost steering box properly.*

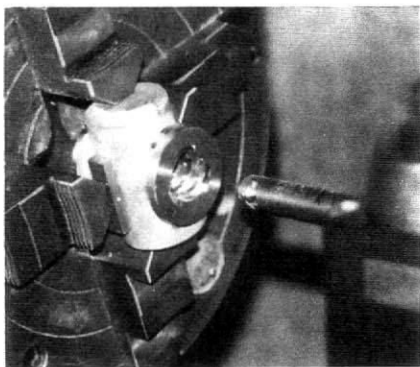
Steering nut casting having the female thread of the worm being cut with the boring bar.

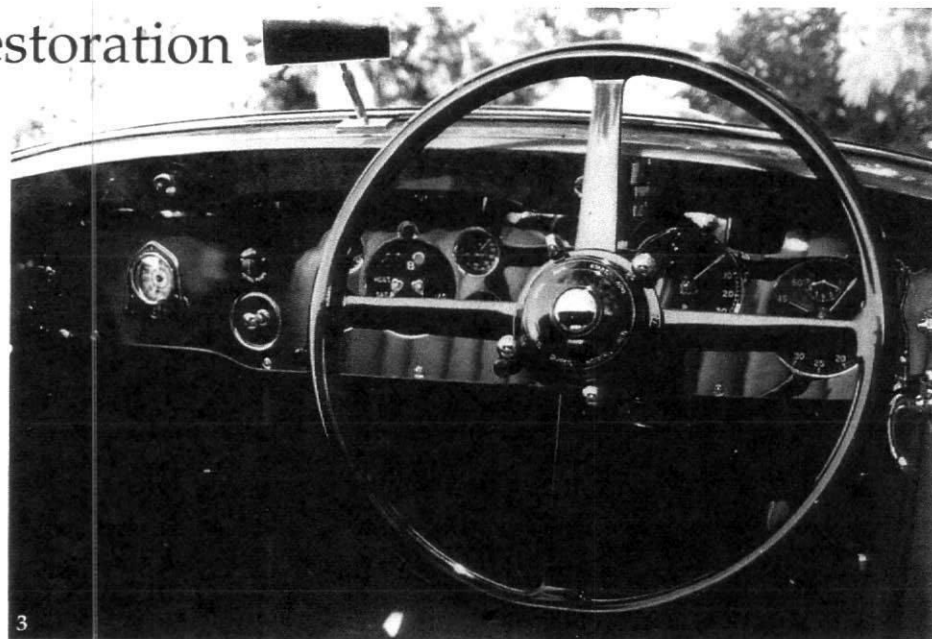
My 3½ L Bentley steering wheel was in terrible shape with cracks at all four spoke/rim joints; spoke coverings peeling, and the chrome on the hub also required replating. I decided to purchase a steering wheel repair kit from The Eastwood Company (1-800-345-1178) for \$21.95 and try restoring it myself. The kit includes 1 lb of epoxy and the pamphlet *Steering Wheel Repair Handbook*.

Finished product. B35BL (1934 3½ L) Thrupp & Maberly dhc.

The handbook was of some help but the Bentley wheel presented some special problems the book did not discuss. The first of these was the need for replating the hub. After removal of the spoke covering it was necessary to drill out the rivets that attach the spokes to the splined hub since, if the two are plated together the corrosive chemicals in the plating bath will seep between the riveted surfaces and ooze out over time. While you may be able to neutralize these chemicals with baking soda and water, you will make polishing prior to plating easier for the plater and achieve a higher quality job if you separate the hub. The chrome plater then taped over the rim and spoke/rim junctions before plating. As you might expect, the tape did not totally exclude chemical entry at each spoke joint and a week later the black rim covering began to get a bumpy appearance as these chemicals began to digest some of the innards

of the rim. I then drilled dozens of holes in this rim cover near the spoke attachment points and soaked the entire wheel in warm water and baking soda for a day to neutralize the chemicals. After this I waited for a couple of weeks to be sure that no further lifting would occur. At this time the wheel was ready for the epoxy coating. The first step was to thoroughly clean the spoke joints (photo 1) with a small grinding wheel in a Dremel grinding tool and then fill the deep areas at each spoke joint (and the many drilled holes) to make a smooth transition to the spoke. Next, I taped off the chrome plated inner spokes and built a ¼ in.-high dam at the inner end of each spoke covering and applied a narrow ridge of epoxy against these dams to be later formed into the ridge at the termination of the epoxy covering on the spokes.

epoxy onto the surface to be repaired. This inevitably leaves a surface that is uneven and it is very difficult to obtain a uniformly thin, level surface by mechanical spreading. Consequently, we decided to experiment by thinning the epoxy with methyl ethyl ketone and spraying this thinned epoxy on the spokes (we used 70 psi with a suction cup gun). [Tech Ed. note: Observe all applicable safety precautions when using spray equipment and potentially toxic chemicals.] Eureka—it worked (photo 2)! The resultant orange peel was removed by carefully scraping the surface with a razor blade and then block sanding. The wheel was then painted with a black catalyzed urethane by Deltron and color sanded using water to prevent loading of the grit. I started with 400 grit and ended with 1500. Final polishing with rubbing compound produced the end result, shown in photo 3.

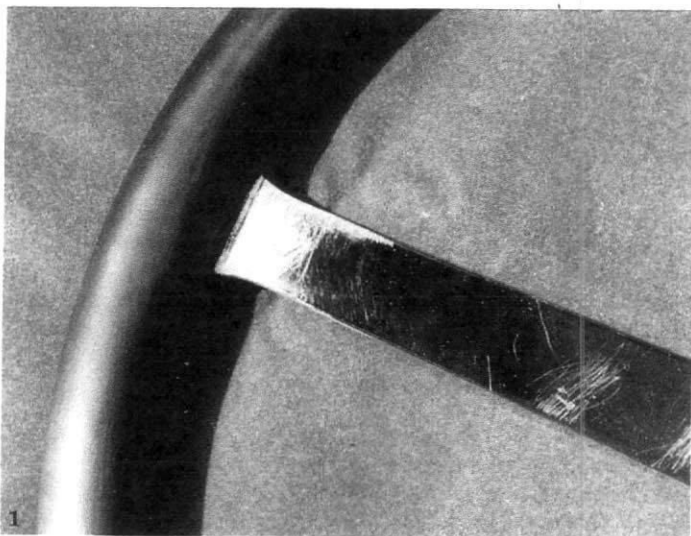
Steering wheel showing spoke and rim after initial preparation.

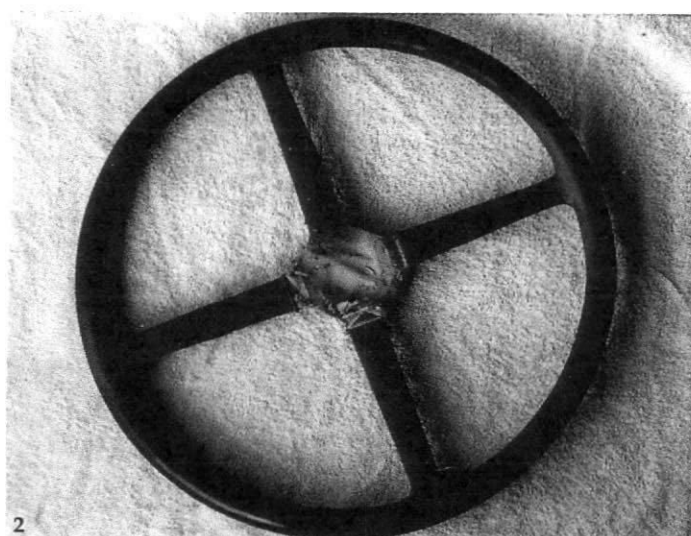
Steering wheel after sanding and prior to painting.
