# From Here to Ether-Ternity

# From Here to Ether-Ternity: Help for B154KT

### FROM PUTTY TO PERFECTION? A BENTLEY RESTORATION PROJECT

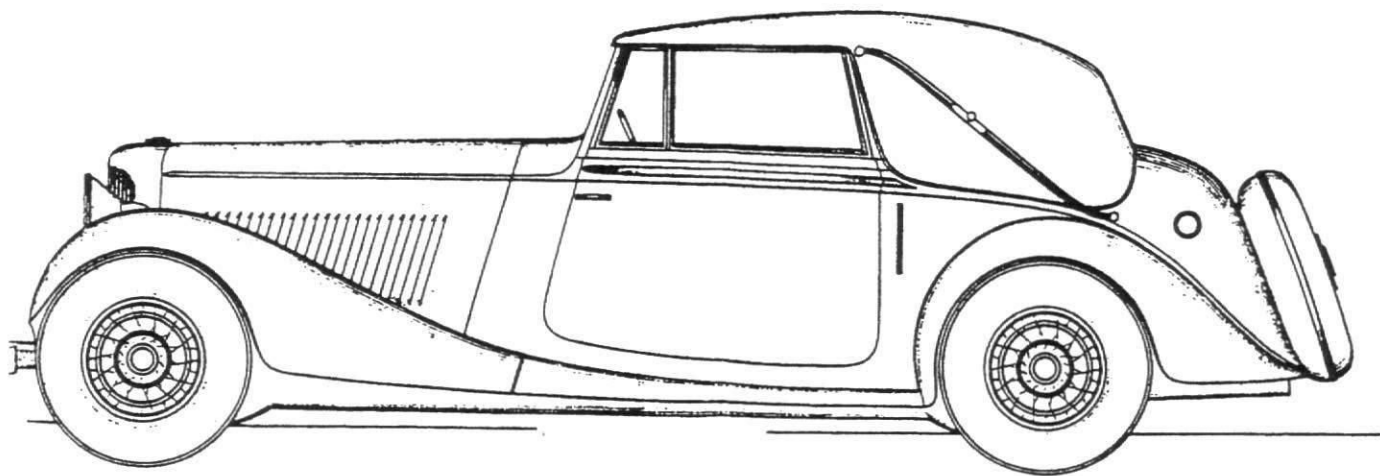
I am a 1937 4¼ litre Vanden Plas drophead. After purchase in the spring in Ohio, I was trucked to a body shop in Batavia, NY (halfway between Buffalo and Rochester) for mechanical checkout and some cosmetic detailing. I was worked over, submitted to tapping and wrenching, sweated over and pampered for about 3 months. My black wheel discs were removed, and my wire wheels were painted cream to match the mid-section of my body (my wings and upper body are a royal blue). I had a new owner, Addison Yeaman in the Washington, DC area, who wanted to drive me home, but did not want to go alone.

It was around Thurmont, MD, that I began to feel sick. I was losing strength and gasping for air. My muffler emitted random embarrassing flatulent pops. Fuel pump trouble was suspected but eliminated. A continuity check of my primary coil/distributor circuit revealed no problem. I limped along for another few miles to Frederick until we reached a shopping mall and found a restaurant where the humans had lunch. I waited outside in the sun with my bonnet up.

We continued south on I-270, stopping in the shade of every other bridge while the humans tried to comfort me, but hills which I breezed over at 60 in top gear now reduced me to a laborious crawl in second. I felt rotten and drugged, and I finally collapsed at the side of the freeway.

"The car started and ran (of course!) as soon as it was off the flatbed truck. It did, however, have a dead miss on two cylinders (#4 and #5). Compression testing showed we had a good basic motor. The ignition system possessed many incorrect parts and was suffering from general neglect. The fuel system proved to be clear, but it was suffering from a partially inoperative pump. The fuel pump proved to have very dirty and corroded valves as well as valve seats which had come adrift. This caused fuel pressure leakage back into the feed pipe to the tank. Coupled with one inoperative solenoid and hardened diaphragms, this would render the pump incapable of delivering fuel at all if any percolation was taking place. This would virtually guarantee a failure on a day when the temperature exceeded 92°-93°F.

"With the fuel pump restored to correct function, and the ignition system sorted out and overhauled along with the rear carburetor piston unstuck and the carbs balanced, the motor went into 'full song.' It does run like a different car, and we were unable to provoke any falter or hesitations on roadtest."

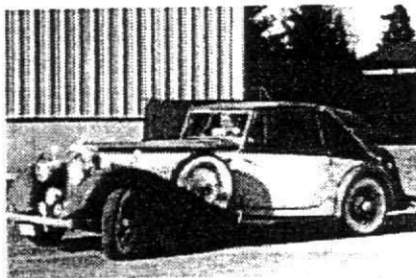
a stout heart and that I could manage the long trip over mountains and deserts to California. And he was right. Despite being a little breathless at 11,000 ft altitude on the Continental Divide, some minor attacks of vapor lock which required the application of a snow poultice to my fuel pumps, plus sundry fuel and roof leaks which were bandaged with much duct tape, I arrived in California with no major assistance required.
